Understanding Njokamoni

River Study, Spatial Patterns, Issues and Potential for Landscape Design

Aaron Dennis

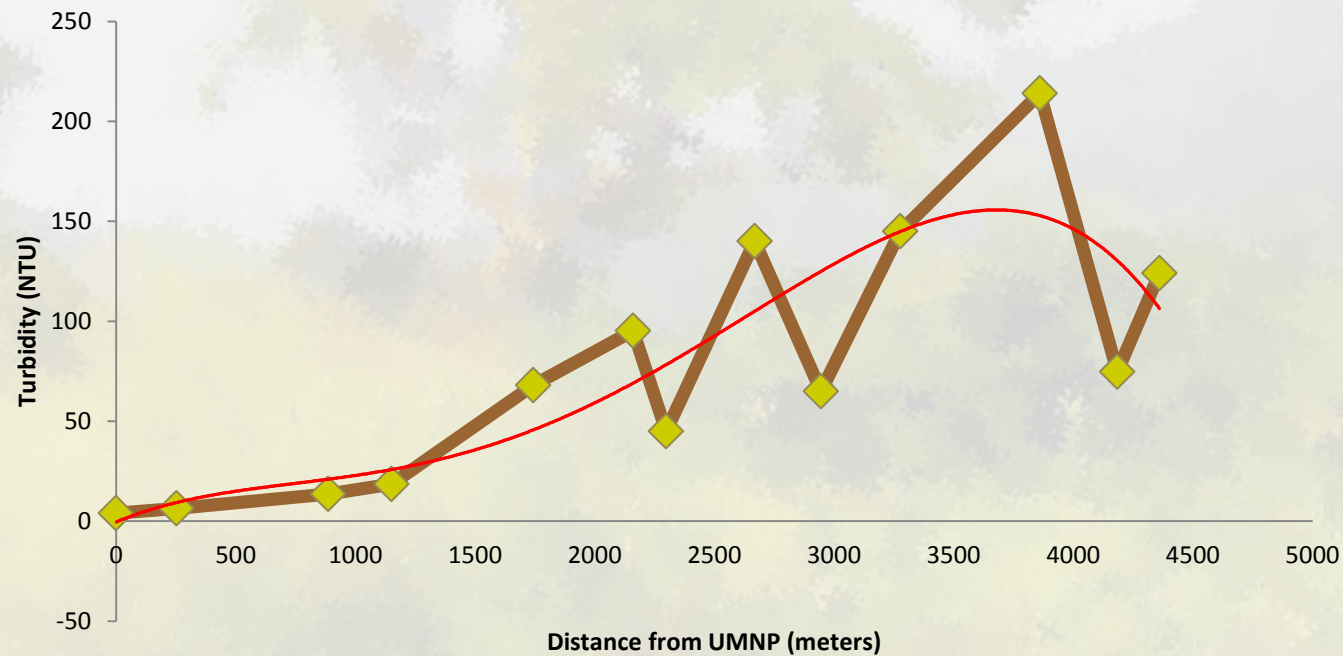
Turbidity in Njokamoni River with Distance from Udzungwa Mountains National Park

Measurements: According to the website of the Environmental Protection Agency of the United States of America (EPA), “Turbidity is a measure of water clarity and how much the material suspended in water decreases the passage of light through the water.” Suspended materials affecting levels of turbidity include soil particles, algae, plankton, microbes, and other substances. Sources of high turbidity levels include soil erosion through run off, waste discharge, and eroding stream banks. Turbidity is a useful indicator of the effects on runoff from agricultural practices (EPA). Turbidity is also a useful indicator of general water quality. Particles in turbid water absorb heat, thereby raising the temperature of the water, which in turn decreases the water’s capacity for dissolved oxygen. Therefore, higher turbidity is normally unsuitable for healthy fish populations, and due to less light passing through the water, capacity for photosynthesis also declines. In this project, turbidity is measured in nephelometric turbidity units

(NTU’s). The EPA’s website says that typical clear mountain streams have a turbidity level of around 1 NTU and large rivers during dry-weather have turbidity measured near 10 NTU, although that number will jump into the hundreds during runoff events. Measurements of water color are taken in American Public Health Association (APHA) cobalt units. APHA is a single number yellowness index (retrieved from www.hunterlab.com). Color is used as an indicator of purity and often reflects organic matter in water .

Methods: Data collection was made on June 6, 2013 in a walkthrough of the entire stream corridor of interest. No significant rainfall had occurred over the week prior to the walkthrough. Observations were made of physical geography, adjoining spatial patterns and human activity. Measurements of turbidity and water color were taken at thirteen different test sites along the studied length of the river.

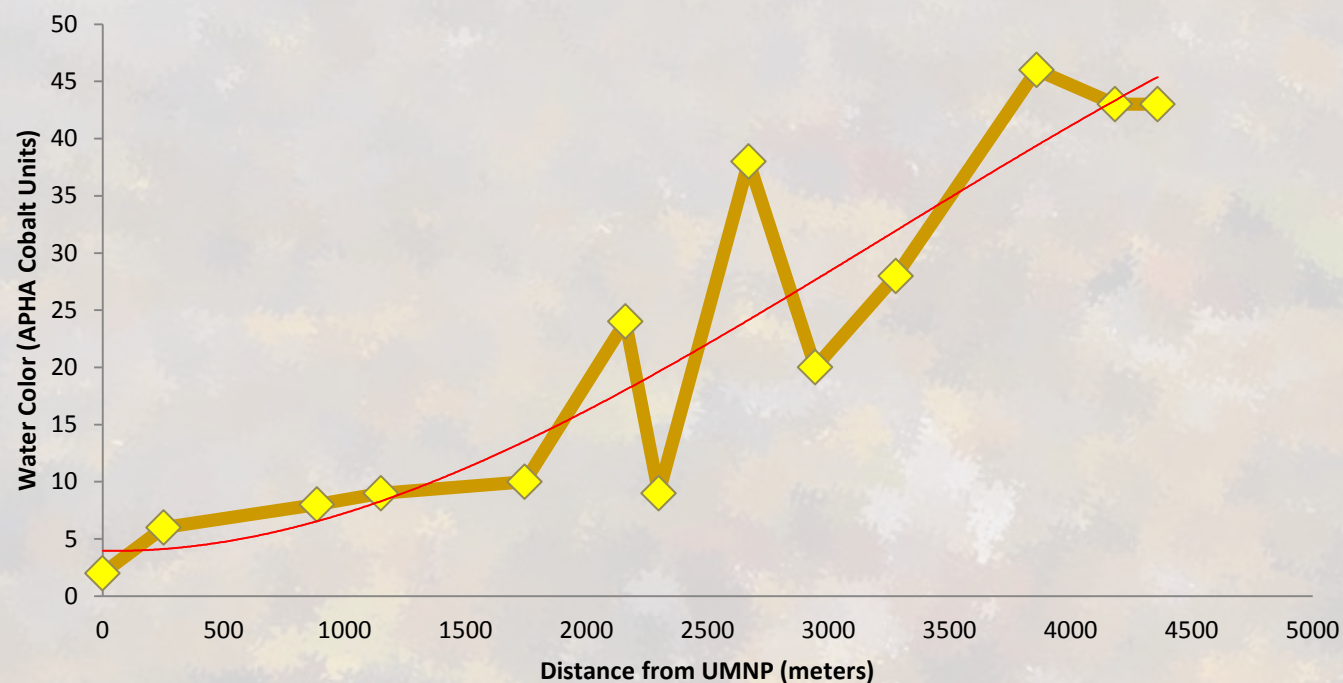
Water Color in Njokamoni River with Distance from Udzungwa Mountains National Park

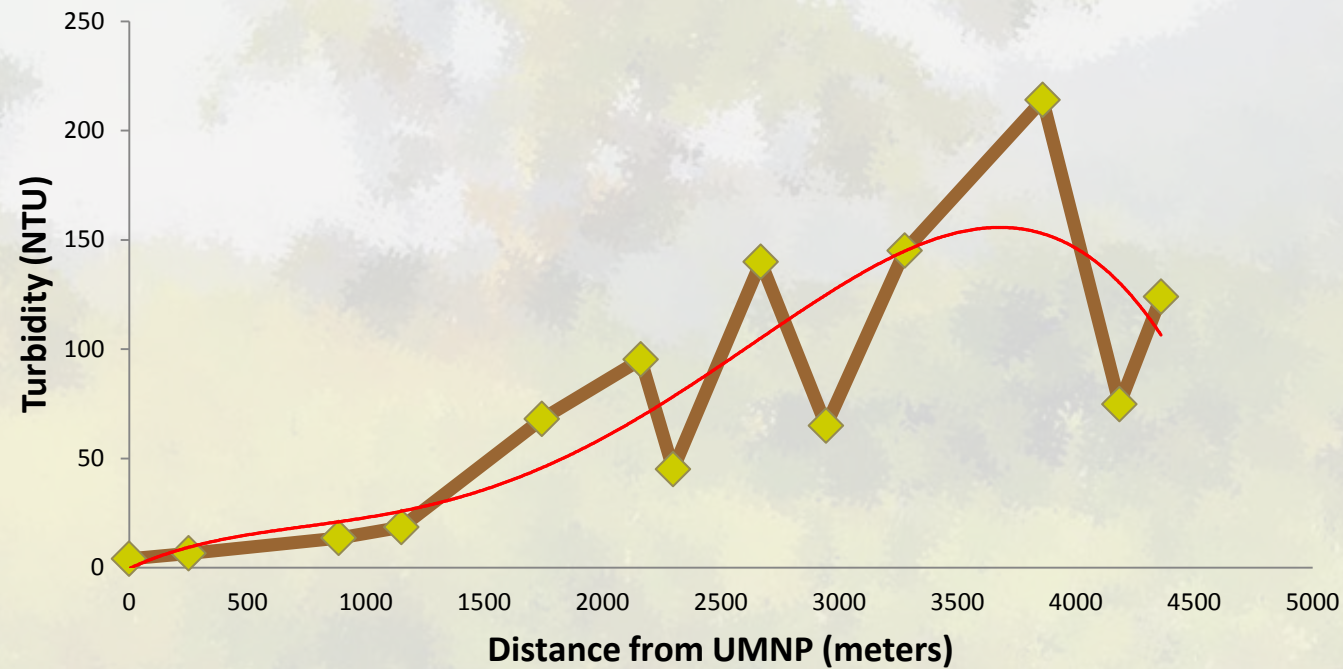
Turbidity

Turbidity: water clarity and how much material suspended in water

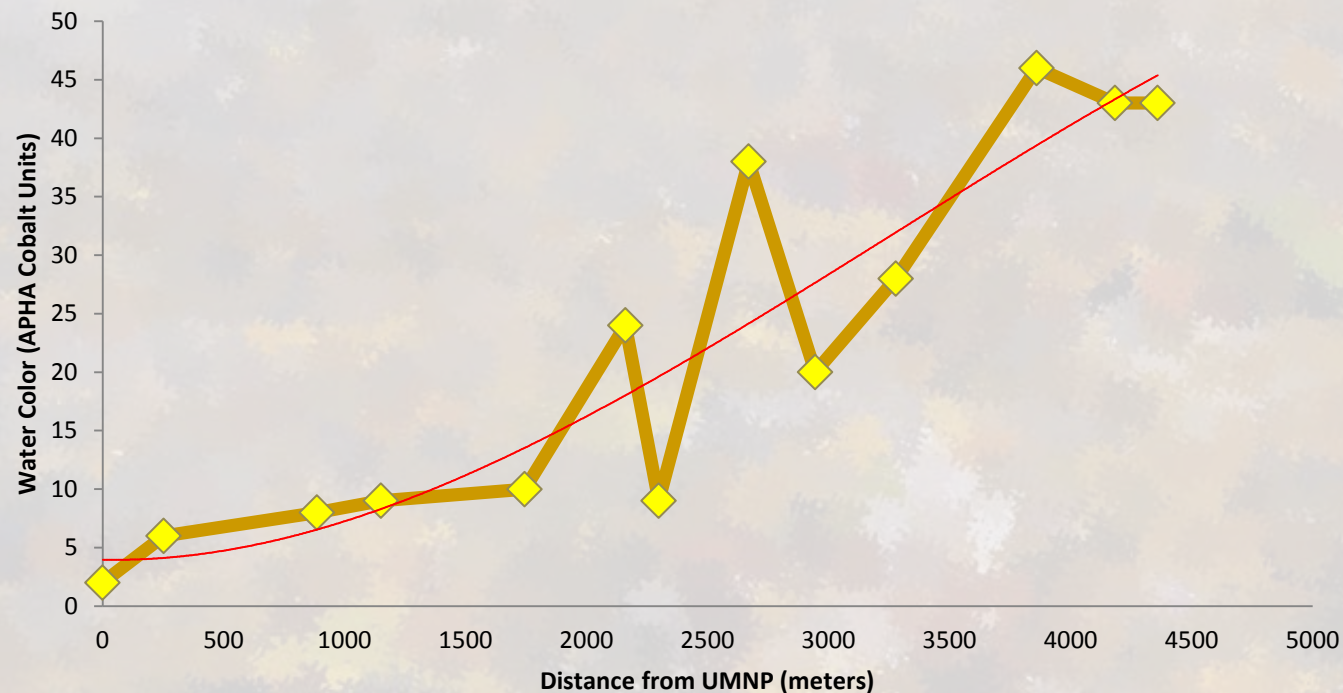
Water Color: measurement of yellowness, clear indicates purity and yellow indicates sediment and organic matter

Water Color
